# Manhole Inspection Summary

Manhole # S23C1\_001MH

**Location** Address: **2404 Huron -Ridgey St**

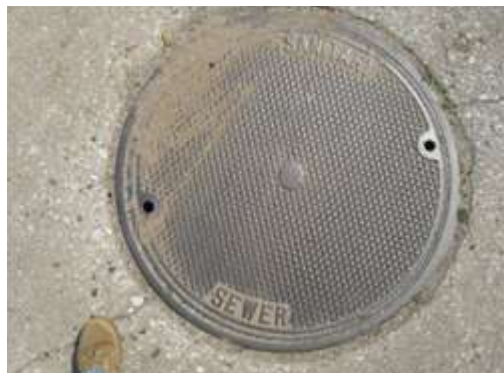
MH Cover

frame leaks

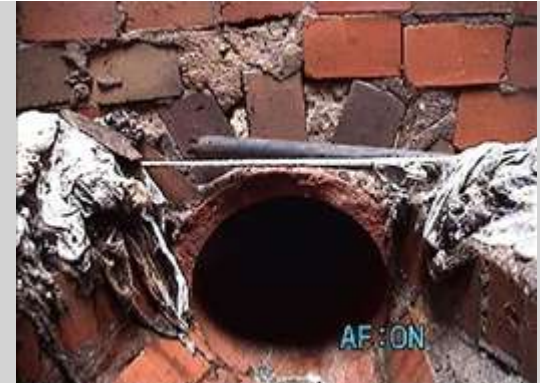
12 O'Clock Outflow

Pipe Height: **8.4** (in.) Rod and Bar (Angled)  
Pipe Material: **Clay** ☐ Pipe Lined  
Invert Depth: **9.31** (ft.) Flow Characteristics: **None**  
Deposits: ☒ None ☐ Mud ☐ Sludge ☐ Debris ☐ Grease  
Silt Depth: **0** (in.) Deposits Extent:  
Infiltration: **None** Pipe Seal Cond: **Sound**

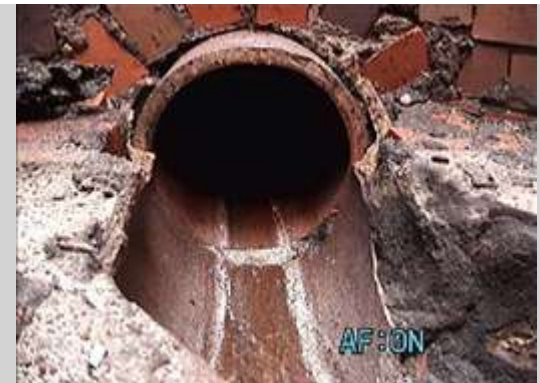
9 O'Clock Inflow

Pipe Height: **8.4** (in.) Rod and Bar (Angled)  
Pipe Material: **Clay** ☐ Pipe Lined  
Invert Depth: **8.85** (ft.) Flow Characteristics: **Slow**  
Deposits: ☒ None ☐ Mud ☐ Sludge ☐ Debris ☐ Grease  
Silt Depth: **0** (in.) Deposits Extent:  
Infiltration: **None** Pipe Seal Cond: **Sound**
